The following article is an original source work from the late 1980s describing the discovery of variable frequency drive induced electrical motor bearing damage by the gentleman who invented SGS™ shaft grounding systems.

## **ABSTRACT**

## **A SERIOUS BEARING FAILURE PROBLEM PROMPTED A CLOSER LOOK INTO ELECTRICAL BEARING DAMAGE**

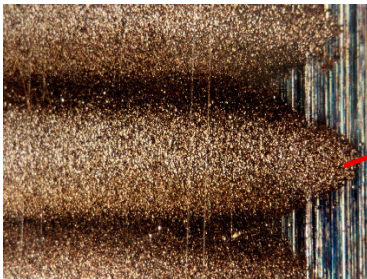
*Figure 1: Micrograph showing detail of bearing fluting. Note the sandblasted appearance and corrugated pattern indicating the motor was running continuously at one speed*

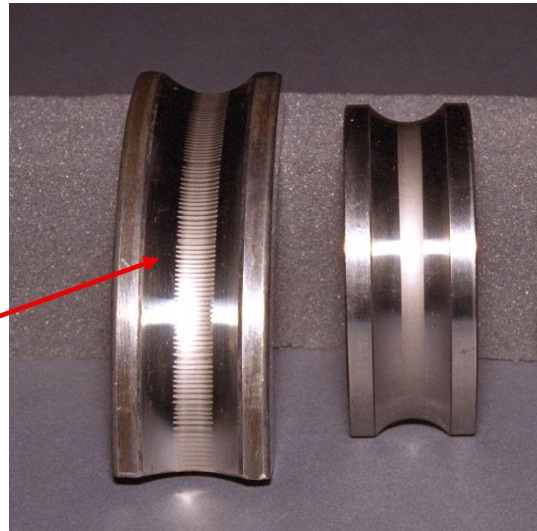
*Figure 2: Sections of bearing inner races. Bearing on left shows more typical fluting pattern. Bearing on right shows frosted pattern indicating this motor was running at different speeds.*

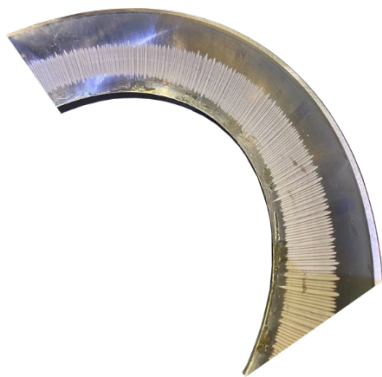
*Figure 3: Washboard fluting pattern from a water treatment plant*

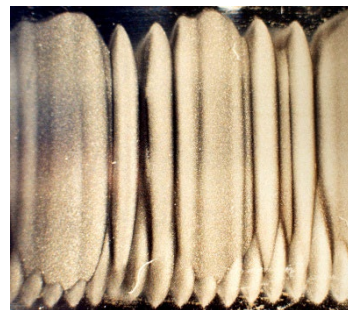
*Figure 4: Micrograph showing bearing fluting with mechanical damage overlay.*

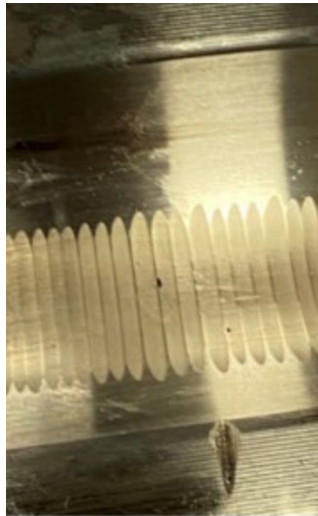
Examples of bearing fluting are shown in figures 1 through 5. Note that the flutes have a very regular “machined” appearance. In the case of the roller bearing race shown, the

fluting is very narrow and closely spaced. This fluting pattern is often seen in association with continuous manufacturing processes that are operated at one speed for several hours at a time. Where running speeds vary widely with no predominate speed, “frosting” may be seen instead of fluting.

*Figure 5: Bearing fluting*

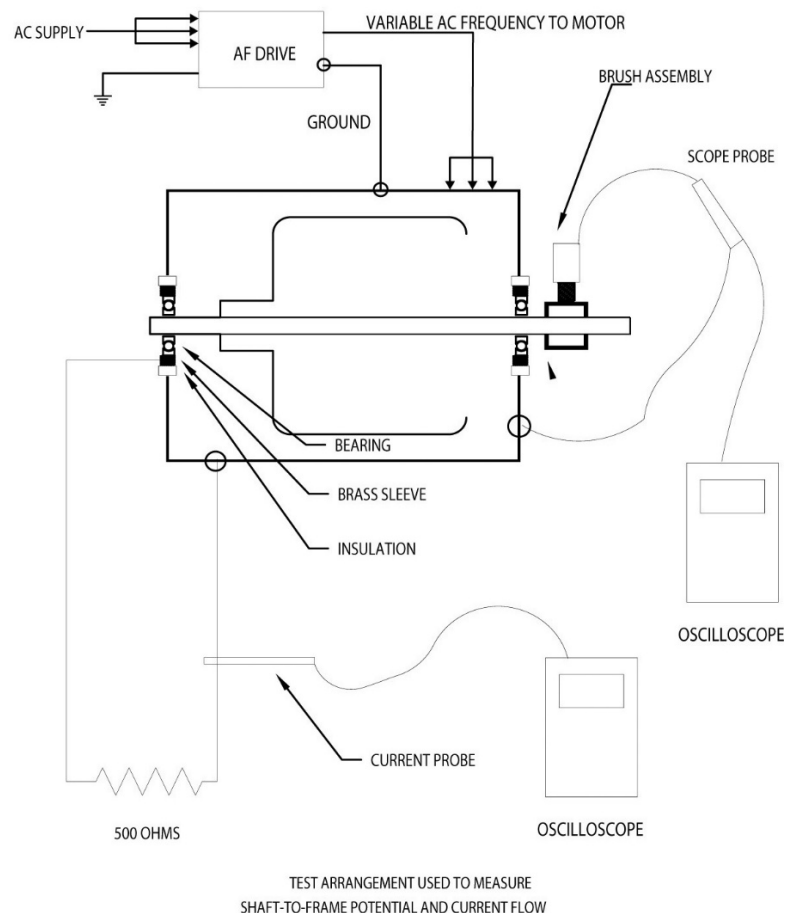
*Figure 6: Test arrangement used to measure shaft-to-frame potential and current flow*

It was determined that an electrical potential existed between the rotating element and the static (fixed) element in DC and AC variable speed motors.

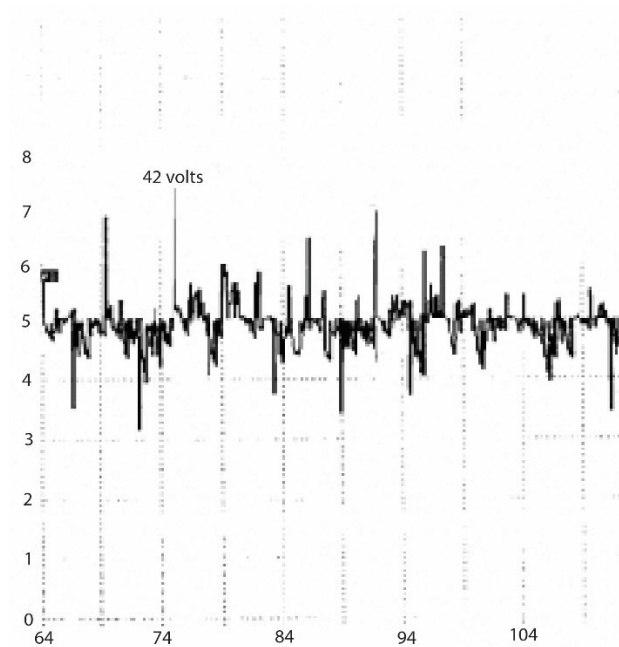
- b) The drives were first connected to a transformer that had twenty DC drives on it, driving the dry end of a paper machine. We measured the shaft potential and we observed spikes as high as 70 volts on the DC motors and 30 volts on the AC motors. The occurrences were sporadic as well, and the polarity of the voltage spikes was variable. (See Figures 7 and 8 showing the oscilloscope traces.)

*Figure 7: Variable speed electric motor shaft-to-frame potential. Note: Shaft not grounding. 20 volts per division. 100:1 scope probe. X-axis is in milliseconds.*

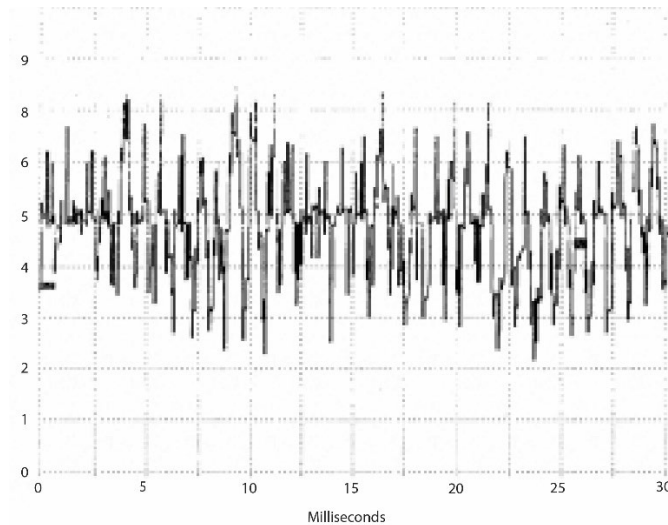
*Figure 8: Shaft-to-frame voltage at 5 volts/division. AC variable speed motor*

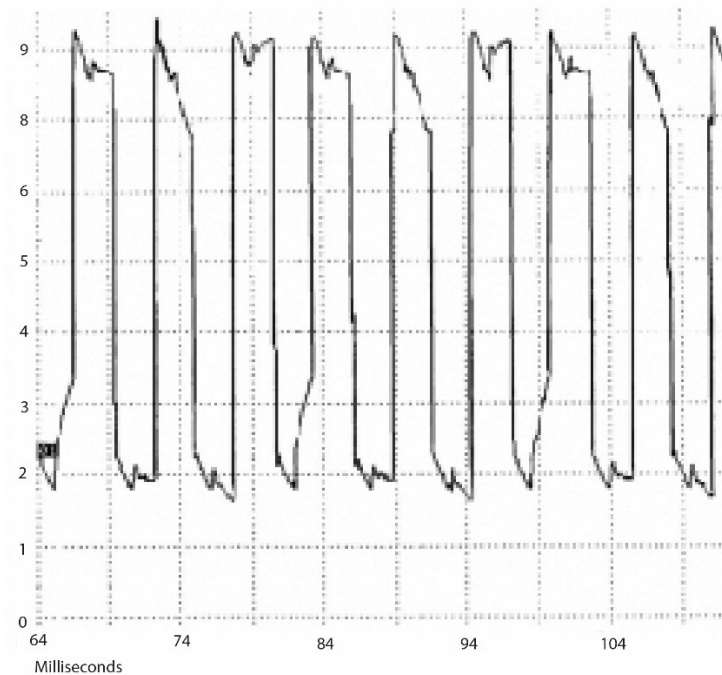
- 4) We then insulated both bearings in the DC motor and observed something that had not been observed up to this point. A voltage level as high as 270 volts, and polarity changing 360 times per second (see Figure 9) was observed.

*Figure 9: DC shaft to frame voltage with insulated bearings.*

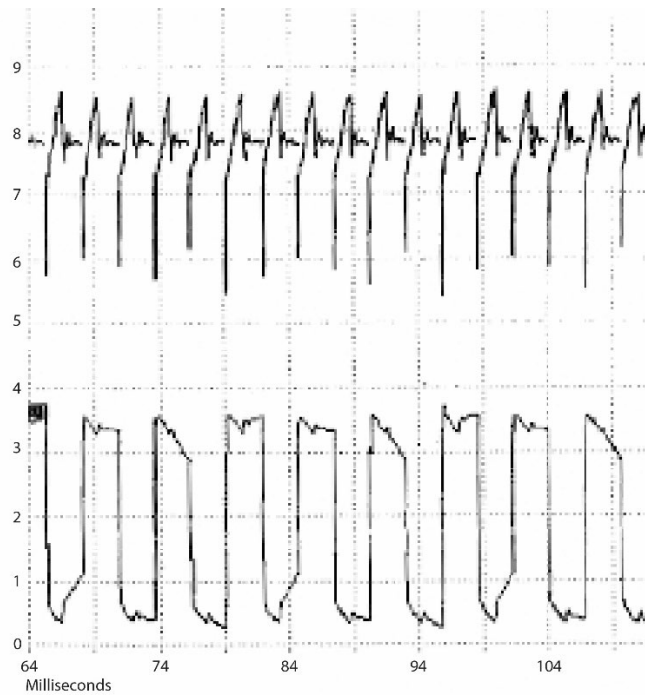
- 5) Using a recording oscilloscope, we recorded the output of the drive going to the DC motor on one channel, and the shaft-to-frame potential on another channel. It was evident that the source of the shaft-to-frame potential was synchronized with the firing of the solid-state drive silicon controlled rectifiers (SCRs). (See Figure 10).
- 6) Next, we repeated these tests using the AC variable frequency drive and motor. The voltages were not as high, but the frequency of the voltage spikes was found to be much higher (see Figure 11). It was apparent that, each time the drive system transistor would turn on or off, the effect could be seen as a shift in the shaft-to-frame potential.

*Figure 10: DC shaft to frame voltage with insulated bearings with SCR firing.*

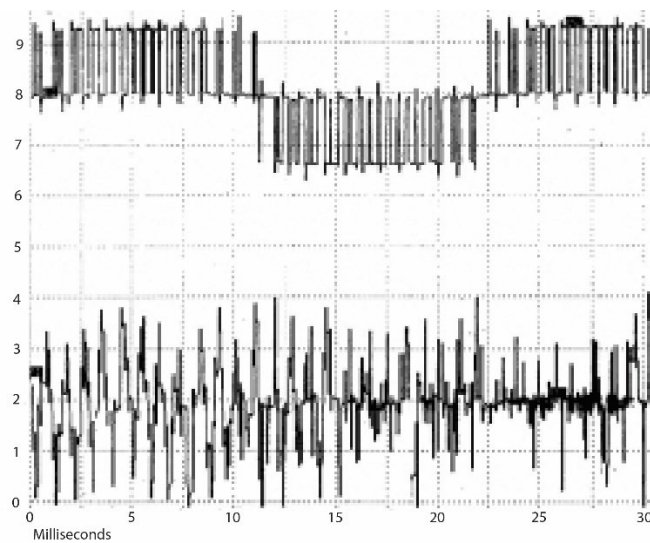
*Figure 11: AC shaft to frame voltage and VFD wave.*

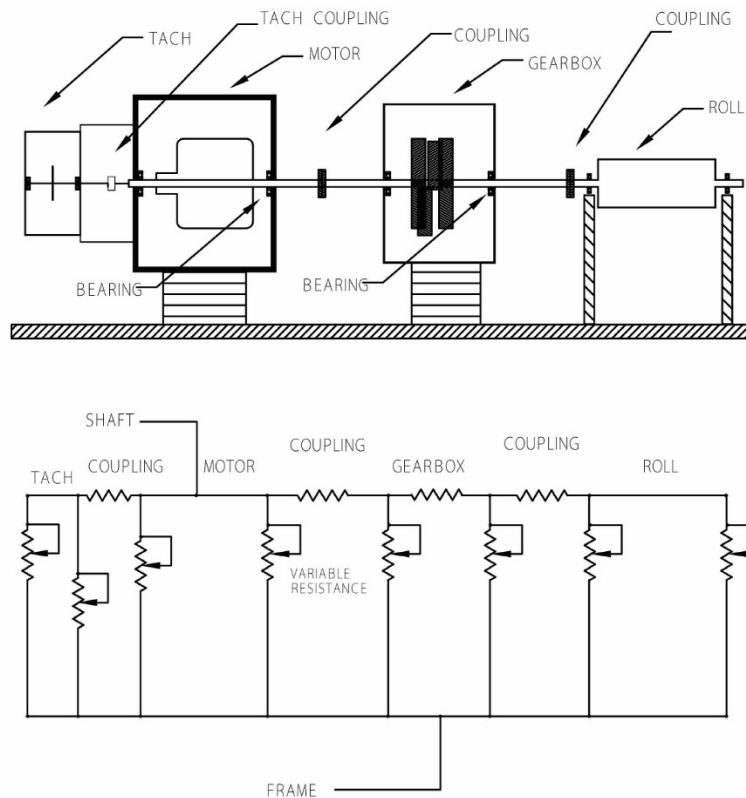
- 1) We tested both units and found that insulating just one end of the motor would actually cause the rate of ED bearing damage to happen more quickly in the uninsulated bearing.
- 2) We also determined that if there was a discharge path available in the motor or connected equipment, and the potential on the shaft rose beyond a certain level, then the dielectric strength of the lubricant would be overcome, and current would flow. (See Figure 12).

*Figure 12: Machinery bearing train and electrical equivalent (bottom) showing multiple electrical pathways from shaft to frame through the bearings.*

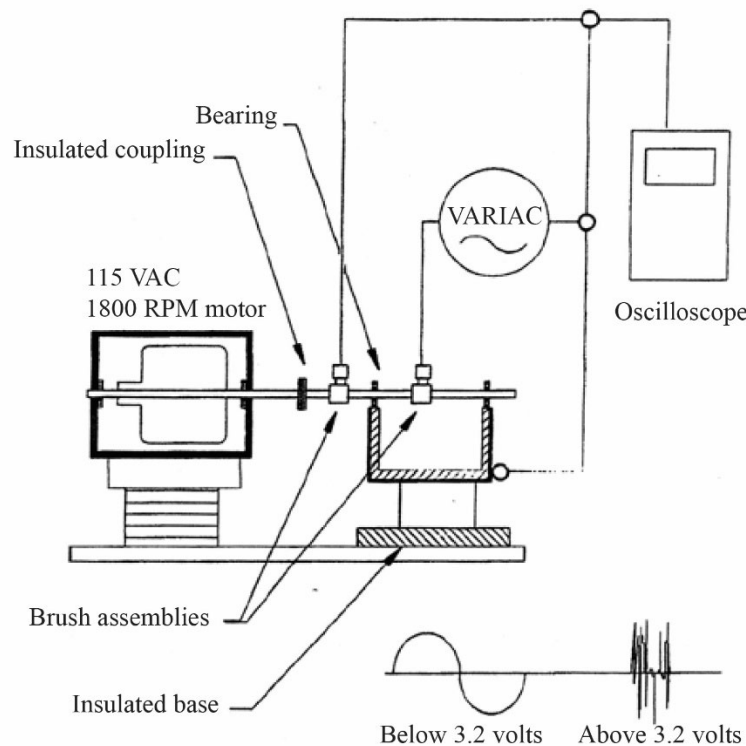
- 3) In trying to identify the “break-over” voltage of the lubricant, we set up a test using a Variac power supply (a variable AC power supply). We took a mild steel shaft and installed two bearings, one on each end of the shaft. The shaft was driven with an 1800rpm motor through an insulated coupling.
- 4) We also installed two insulated electrical brush holders, one at each end of the shaft. On one of the brush holders, we connected one side of the variable AC power source and connected the other side to the two bearing housings.
- 5) The Fluke oscilloscope was connected to the other brush holder, and the ground was connected to the two bearing housings (See Figure 13).

*Figure 13: Test unit to identify break-over voltage when current will flow through bearing.*

- 6) When the voltage on the shaft was below 3.2 volts, we saw a 60hz sinusoidal wave form. When the potential on the shaft exceeded 3.2 volts, we saw an erratic looking signal on the oscilloscope, suggesting current had begun to flow. When the voltage was lowered below 3.2 volts, the 60hz sinusoidal wave form would return.

Our conclusion is that the break-over voltage is dependent upon the thickness of the film lubricant and on other motor running conditions such as temperature.

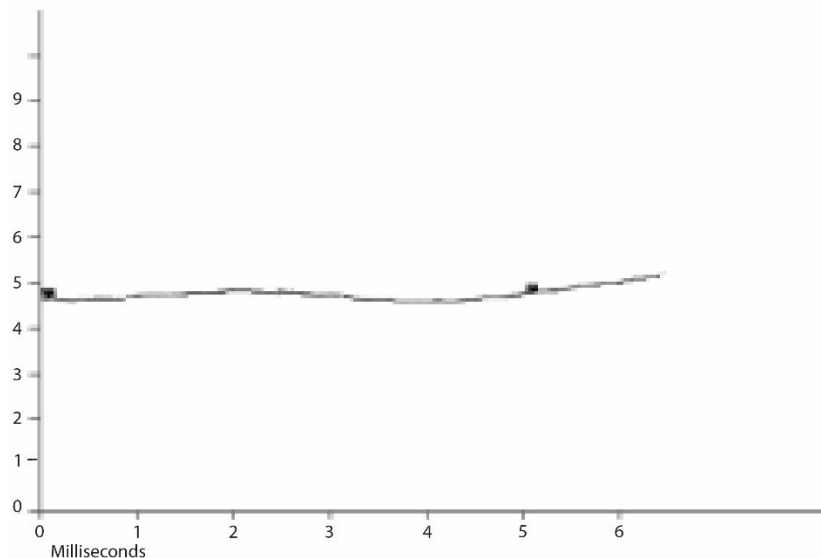
The shaft-to-frame potential on a conventional (non-adjustable frequency) AC motor was tested. This data was taken with the motor running “across the line” (not running on a variable frequency drive). Voltage levels ranging from 0.1 volt to 2 volts were measured. The voltage seemed to vary this amount from motor to motor. As long as there was not any current flow, there was no damage to the bearings (See Figure 14).

*Figure 14: AC motor shaft to frame voltage across the line (not running on a VFD).*

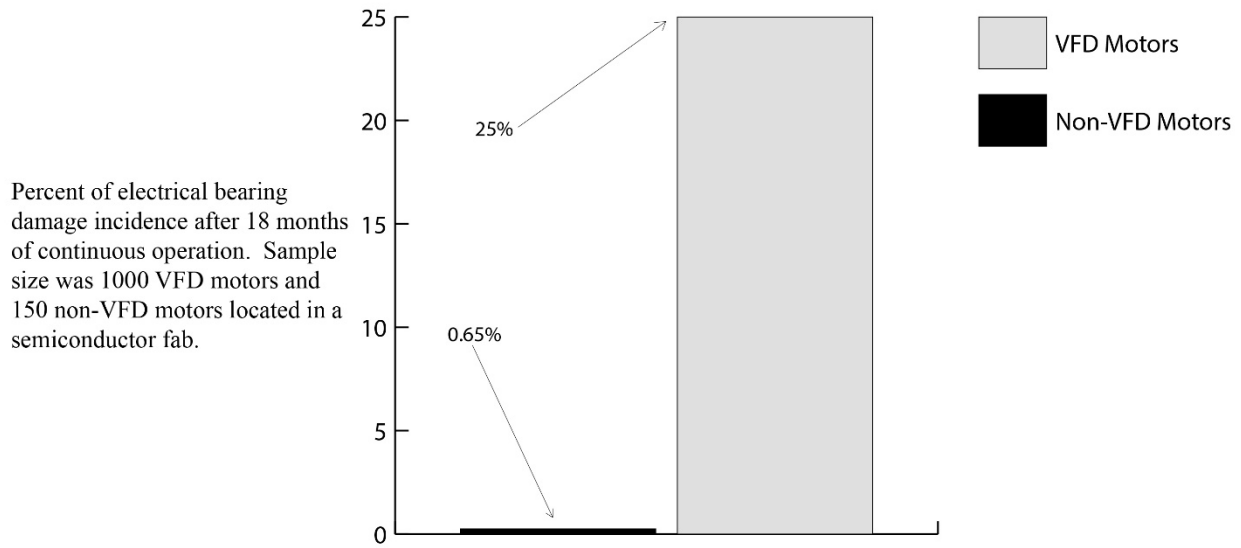
### Incidence Rate of Electrical Bearing Damage Detected Using Vibration Analysis on 1,150 motors.

After having identified that VFDs were responsible for electrical bearing damage, we carried out a large study in a semiconductor plant using vibration analysis on 1,150 AC motors. One thousand of these motors were powered by variable frequency drives (VFDs). One hundred and fifty motors were non-variable speed driven (across the line). These motors were all used in similar clean room applications (See Figure 15).

The data showed that 25% of the VFD motors in operation for less than 18 months had bearing damage caused by electrical discharge (ED). The data also showed that 65% of VFD motors that had been in operation for greater than 18 months, with an average age of two years, had ED damaged bearings.

The 150 motors that were running across the line were found to have an incidence of bearing damage of less than one percent (See Figure 15). This problem is not limited to the clean room industry or to AC motors. We have seen DC motor bearing damage due to ED in every industry examined to date. A consultant in California said 90% of the bearing damage he has seen in DC motors has been caused by current flow through the bearings.

Of note: At 2 years, the incident rate increased to 65% when a follow-up was performed on 100 of the 1000 VFD motors.

*Figure 15: Incident rate of bearing damage in non-VFD and VFD motors at 18 months.*

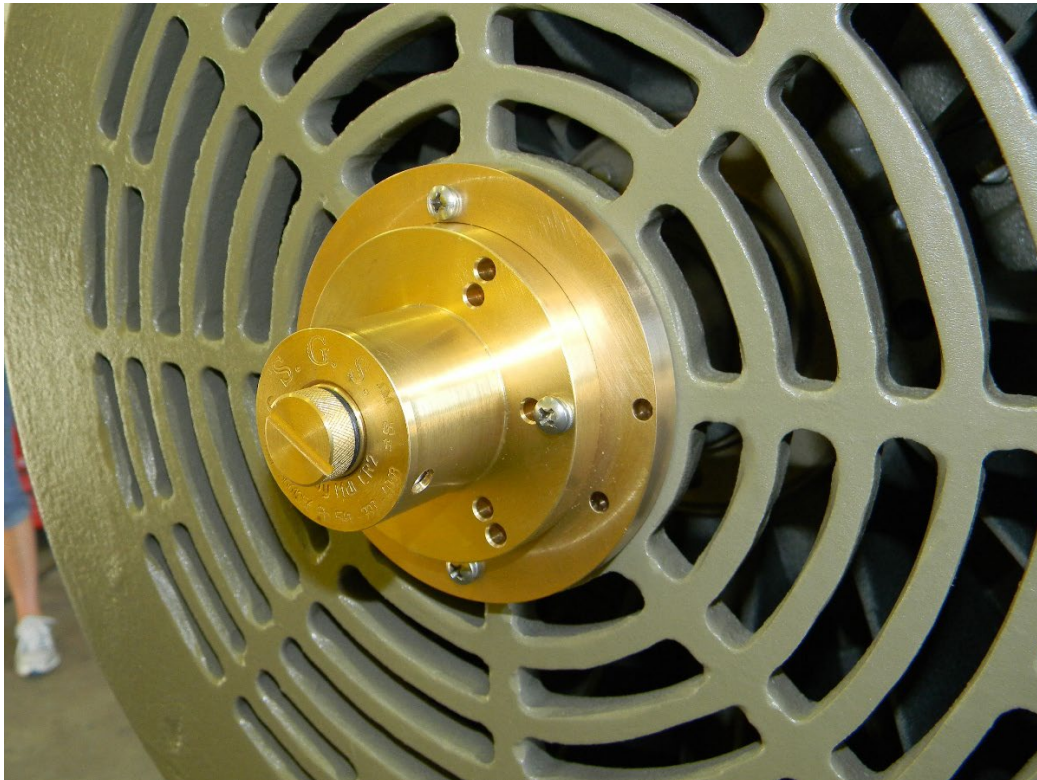
*SGS™ CR Series model shaft grounding system for non-drive end of motor. Sealed from the environment and expected to run continuously for 10 years at 1800rpm. Drive end models also available.*

The way to prevent ED is to provide a safe, very low impedance path that will allow the potential to be reduced so that the bearing will not be damaged. This is done by electrically connecting the rotating shaft to the frame.
